International Journal of Physical Education, Sports and Health

Detecting late infected hip prosthesis via ultrasonography: A case report

Keywords: Fluid, hip replacement, septic prosthesis, ultrasound

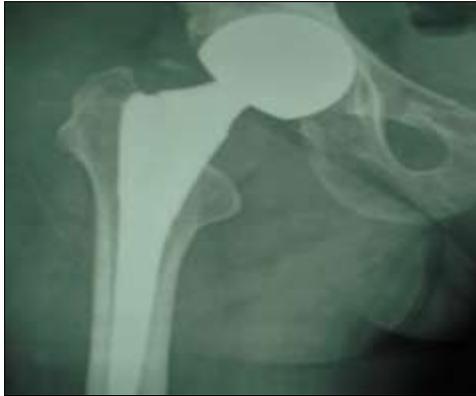
Fig 1: Roentgenograms of the hip hemi-arthroplasty.

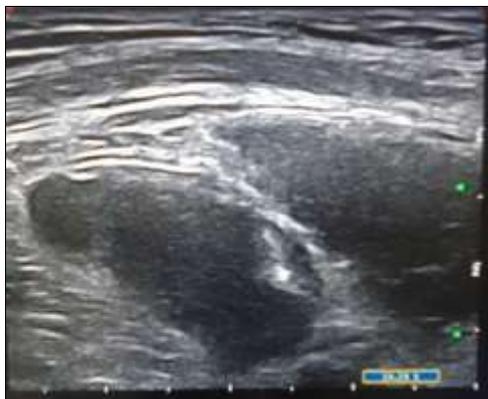
A 64 years old lady presented to Accident and Emergency (A&E) Department complaining of right hip pain when she tried to sit up off a chair. From the Past Medical History, she was on anti-osteoporotic treatment and she had a non-cemented hip hemi-arthroplasty 10 years ago because of a Neck of Femur fracture. On clinical examination she was able to lift up her leg, but she complained of moderate groin pain. Neurologic examination was negative. Radiographs were negative for a periprosthetic fracture or signs of gross loosening (Figure 1). Since the symptoms had started 10 years after the operation, the diagnosis of septic arthritis was not included in the differential diagnosis. She visited her surgeon who sent her for a computed tomography (CT) scan, since a scintigraphy scan was not available and the presence of the stainless steel stem prohibited an accurate magnetic resonance imaging (MRI) diagnosis. The CT scan report was "Swelling around the iliopsoas and gluteus medius. There is a hyperintense lesion within the gluteus medius mass (possible haematoma). Artifacts around the prosthesis make proper evaluation difficult. Old united ischiopubic rami fracture. Possible hairline trochanteric fracture". When she visited the outpatient clinic, she was barely walking. Full Blood Count (FBC) was within the normal limits but she had an elevated c-reactive protein (CRP). Radiographs of the hip showed no changes in comparison to the initial ones (when she first presented to the A&E). She was examined by the orthopaedic doctor, who used an EsaoteMylab 70 X-vision ultrasound. The patient was slim and a linear probe 13 MHz was initially used. Then the hip evaluation completed using a convex probe 8 MHz. A large superficial fluid collection was found (Figure 2). Using the convex probe another fluid collection around the prosthesis was discovered (Figure 3).

Fig 2: Large superficial fluid collection.

In the present study ultrasound immediately revealed large fluid collection areas around the prosthesis extending up to the more superficial soft tissues layers. Such a large fluid collection is not always the case of the low grade prosthesis infection making the ultrasound diagnosis more difficult.

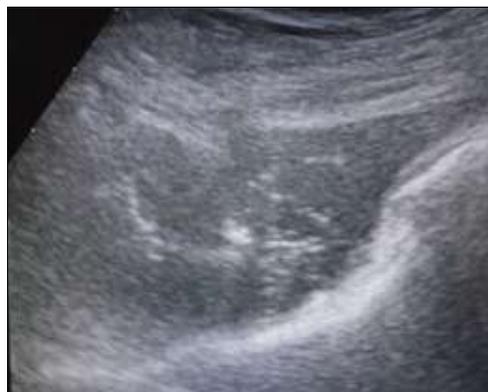
Fig 3: Fluid collection (snowstorm picture) around the neck of the prosthesis.

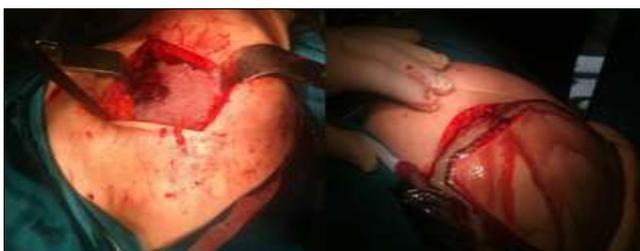
This finding plus the elevated CRP led the surgeon to proceed to an open procedure. After the incision of the fascia latta, a large amount of pus gushed out of the surgical wound (Figure 4). All the hardware was removed and treatment with intravenous antibiotics was initiated according to the cultures' results.

Fig 4: Massive pus collection evacuated from the wound.
